Manhole Inspection Summary

Manhole # S45I2_021MH

Insp Date: **1/7/08 12:32 PM**

Location Address: **1412 Elmtree St**

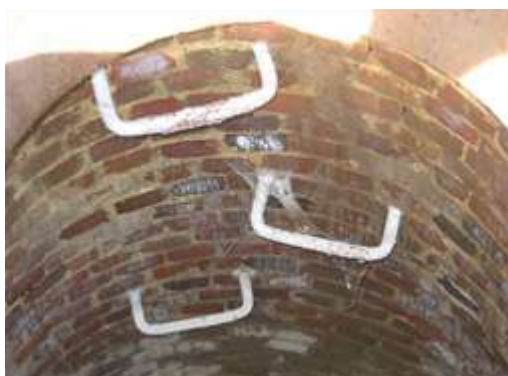
Steps Count: **3** Missing: **0** ☐ Corroded

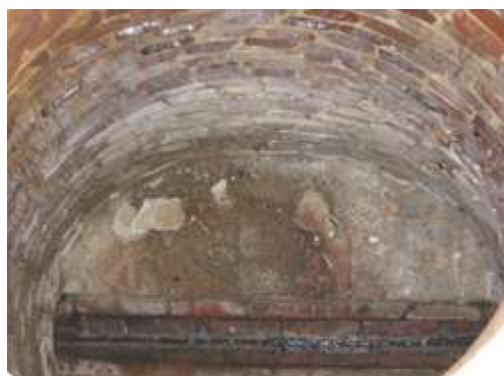
Defect 1

Debris

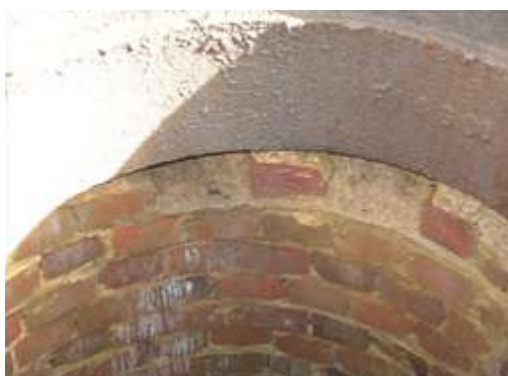
Defect 2

Condition: ☐ Sound ☐ Cracked ☐ Root Intrusion ☒ **Loose Brick** ☐ Deteriorated

Loose bricks

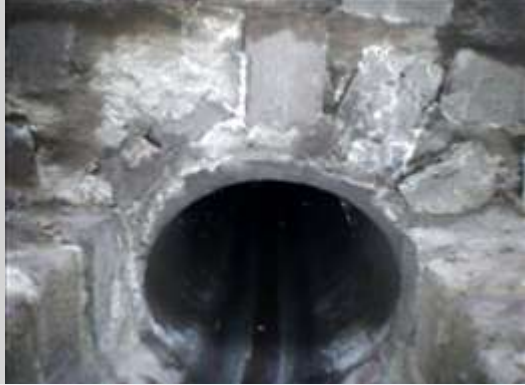
12 O'Clock Outflow

8 in. Circular Gravity Sewer
Pipe Out @ 12 O'Clock

Pipe Height: **8.4** (in.) Rod and Bar (Angled)
Pipe Material: **Clay** ☐ Pipe Lined
Invert Depth: **7.15** (ft.) Flow Characteristics: **Fast**
Deposits: ☒ None ☐ Mud ☐ Sludge ☐ Debris ☐ Grease
Silt Depth: (in.) Deposits Extent:
Infiltration: **None** Pipe Seal Cond: **Sound**

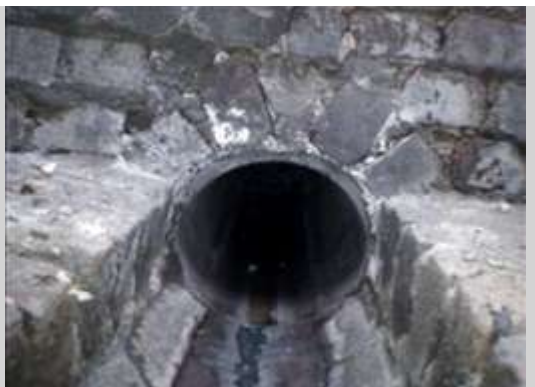
6 O'Clock Inflow

8 in. Circular Service Sewer
Pipe In @ 6 O'Clock

Pipe Height: **8.4** (in.) Rod and Bar (Angled)
Pipe Material: **Clay** ☐ Pipe Lined
Invert Depth: **6.91** (ft.) Flow Characteristics: **Fast**
Deposits: ☒ None ☐ Mud ☐ Sludge ☐ Debris ☐ Grease
Silt Depth: (in.) Deposits Extent:
Infiltration: **None** Pipe Seal Cond: **Sound**
